LABORATORY AND FIELD INVESTIGATIONS
EXAMINING
THE INHIBITION OF
ACID GENERATION FROM PYRITIC MATERIALS

PERD COAL WASTE ROCK PILES
FIELD OBSERVATIONS AND REPORT

Fred Baechler

RE: Investigation of Perd Piles at CBDC's VJCPP

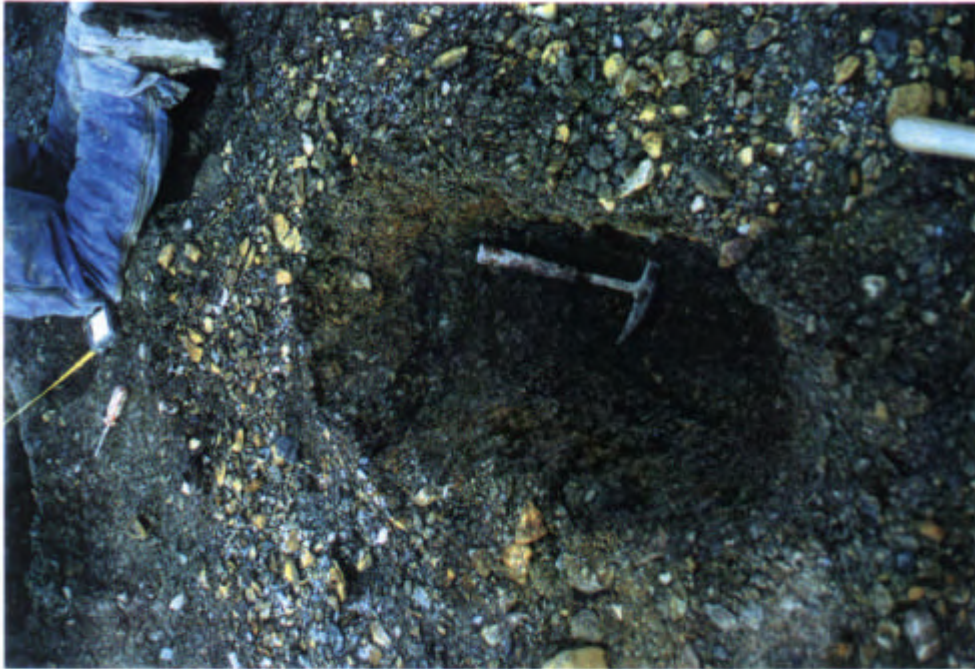
Plate 42: PERD Pile 4, Compacted, No Amendment, November 11-13, 1996. Toe of slope pit.

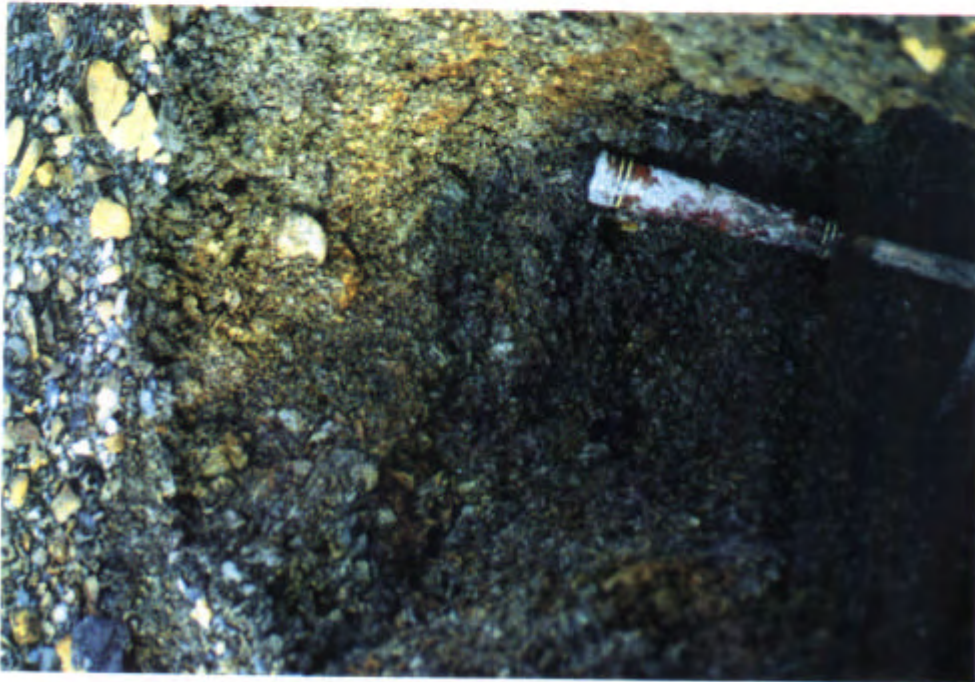
Plate 43: PERD Pile 4, Compacted, No Amendment, November 11-13, 1996. Toe of slope pit.

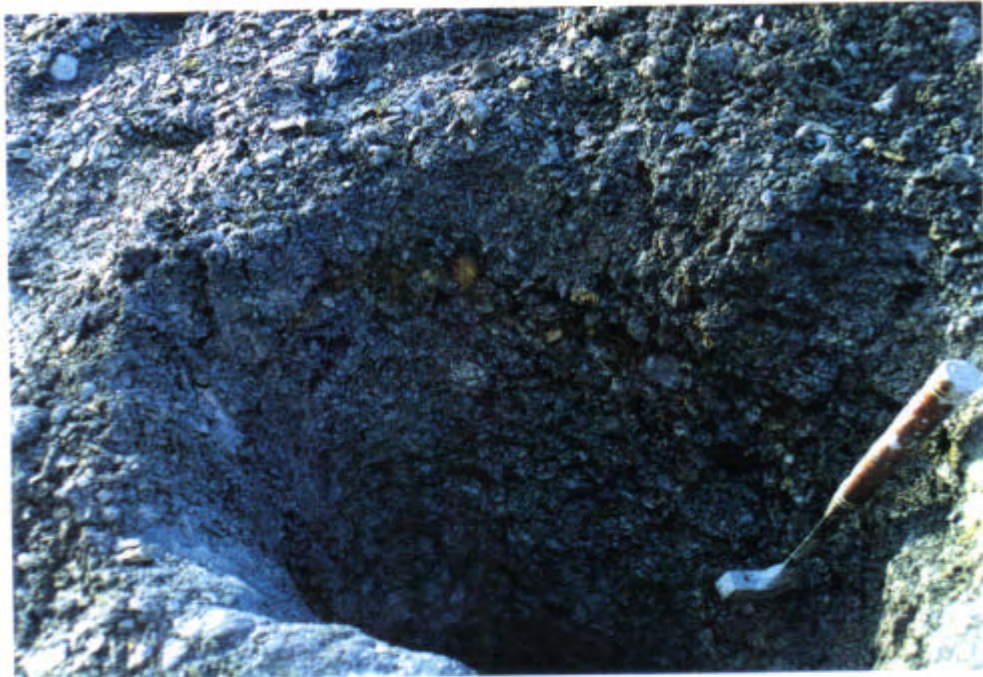
Plate 44: PERD Pile 4, Compacted, No Amendment, November 11-13, 1996.
Mid-slope pit.

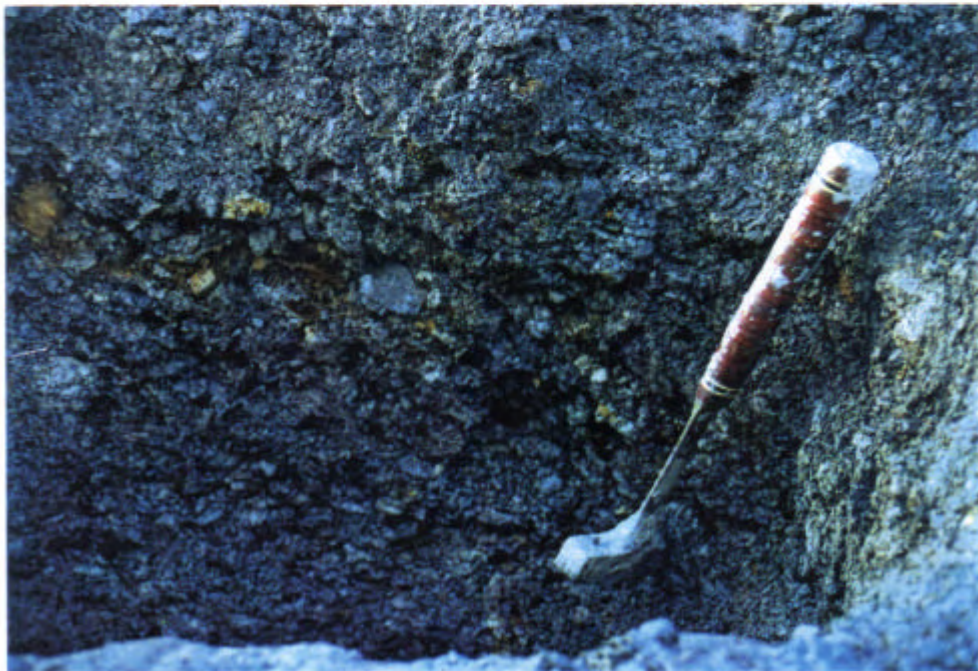
Plate 45: PERD Pile 4, Compacted, No Amendment, November 11-13, 1996.
Mid-slope pit.

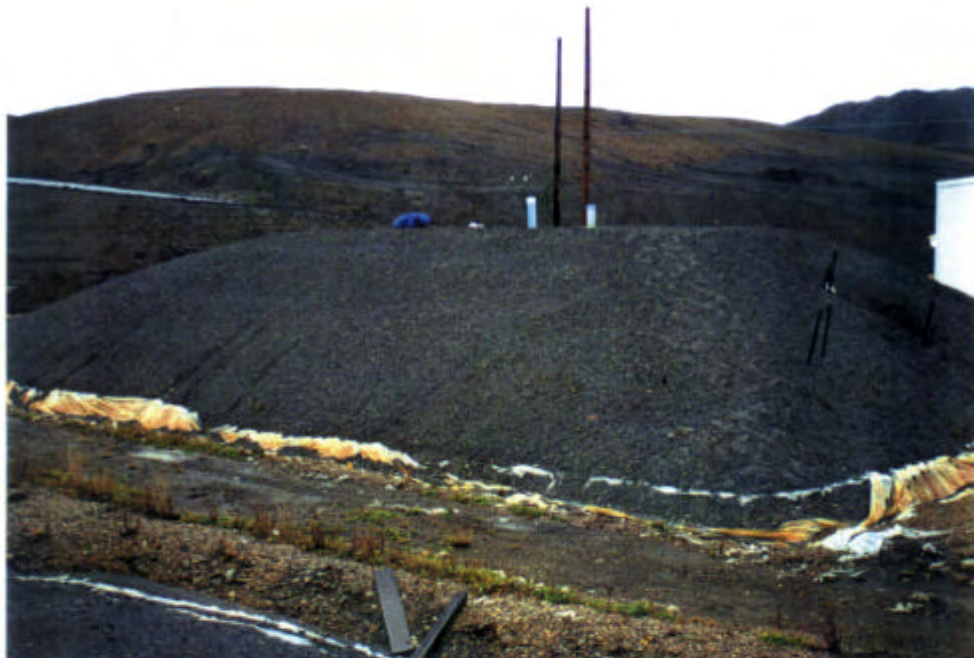
Plate 46: PERD Pile 5, Compacted, Phosphate Amended, November 11-13, 1996. Overview of N-facing slope.

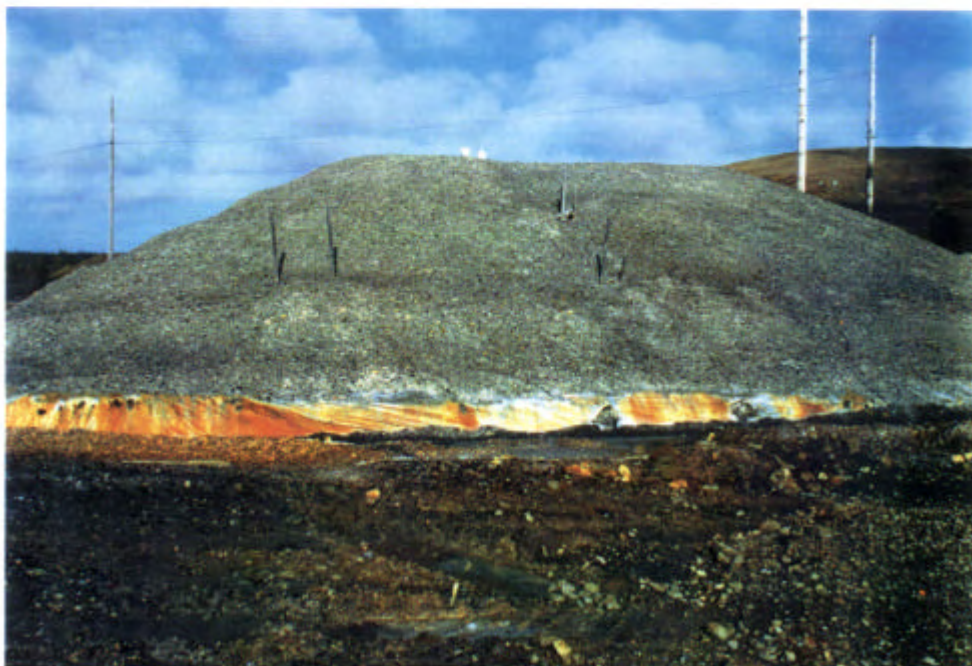
Plate 47: PERD Pile 5, Compacted, Phosphate Amended, November 11-13, 1996. Overview of W-facing slope.

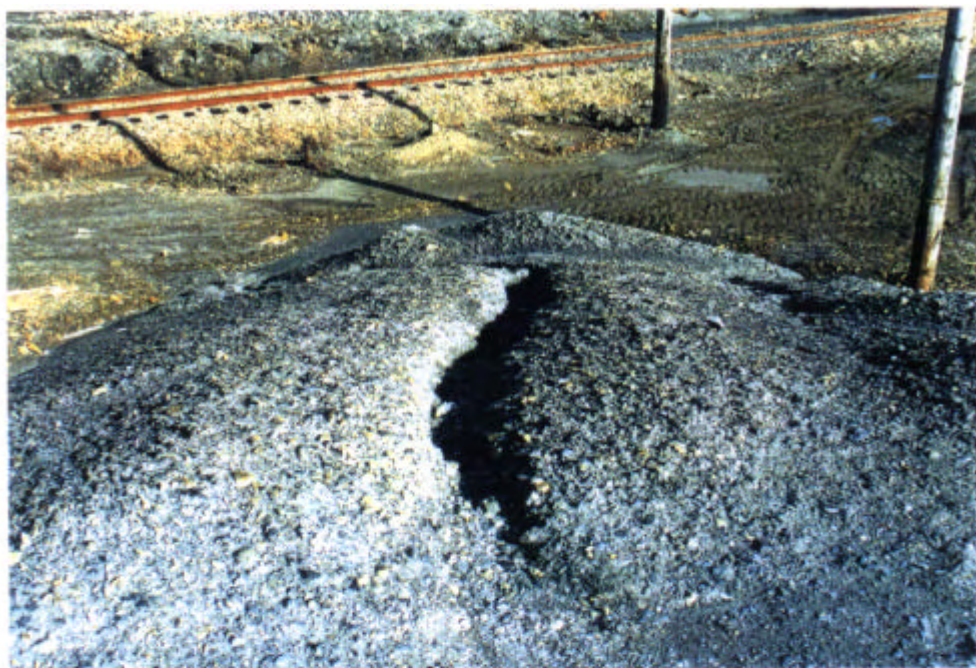
The hardpan did control the depth of gullying by creating an essentially non-erodible base. In this area the surface of the hardpan was smooth; there were no cracks noticeable all the way down the slope.

Plate 48: PERD Pile 5, Compacted, Phosphate Amended, November 11-13, 1996.
Rill created by erosion at S-E corner.

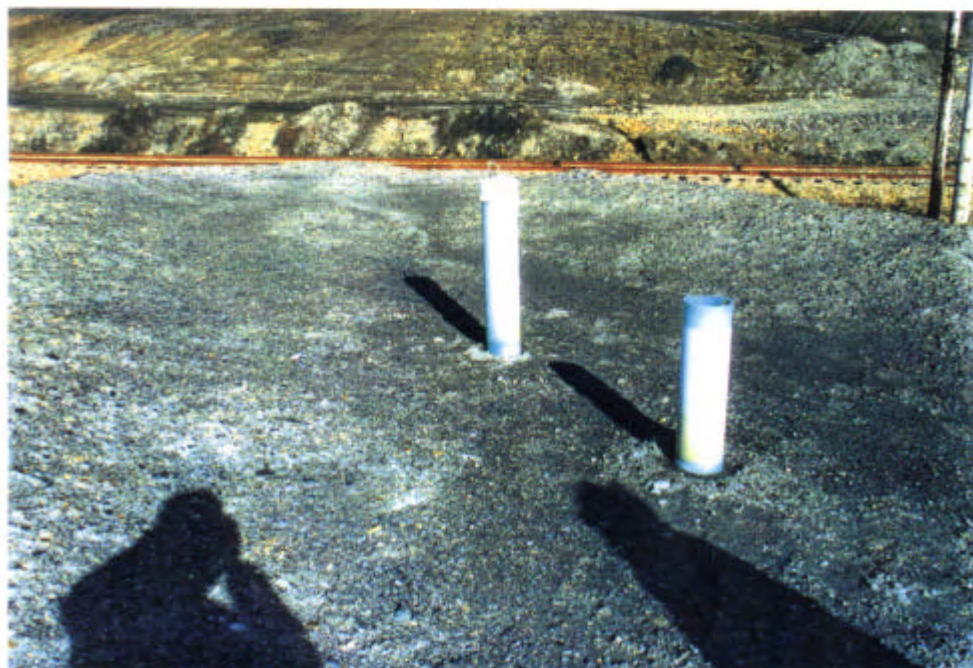
- *Test Pit on Top of the Pile:*
Two 0.3 x 0.6 m pits were excavated by hand in the surface depression to a depth of 0.3 m (10% of the total depth of the pile). The surface lag pavement was obscured by deposition of fines over the center of the depression. Both pits exhibited similar conditions. From the surface, down to the top of the phosphate layer, (approximately 0.2 m) was loose, weathered, "grey" coarse waste as noted in Piles 1 and 4. There was evidence of slight "yellow" mottling immediately above the phosphate hardpan layer indicating possible ephemeral perched conditions. Most of the phosphate layer had been turned into a very strong, "orange brown" hardpan, approximately 2-3 cm thick; which came to the surface as cemented blocks. This colour ranged from dark yellowish orange (10YR6/6) to moderate yellowish brown (10YR5/4). The natural phosphate sand was a light brown (5YR5/6). The pan was difficult to dig through and was dry; some phosphate sand was sporadically present under the hardpan which had not been altered as yet. The hardpan was underlain by relatively fresh, black, compacted, coarse, waste rock.

Plate 49: PERD Pile 5, Compacted, Phosphate Amended, November 11-13, 1996.
Depression on top of pile.

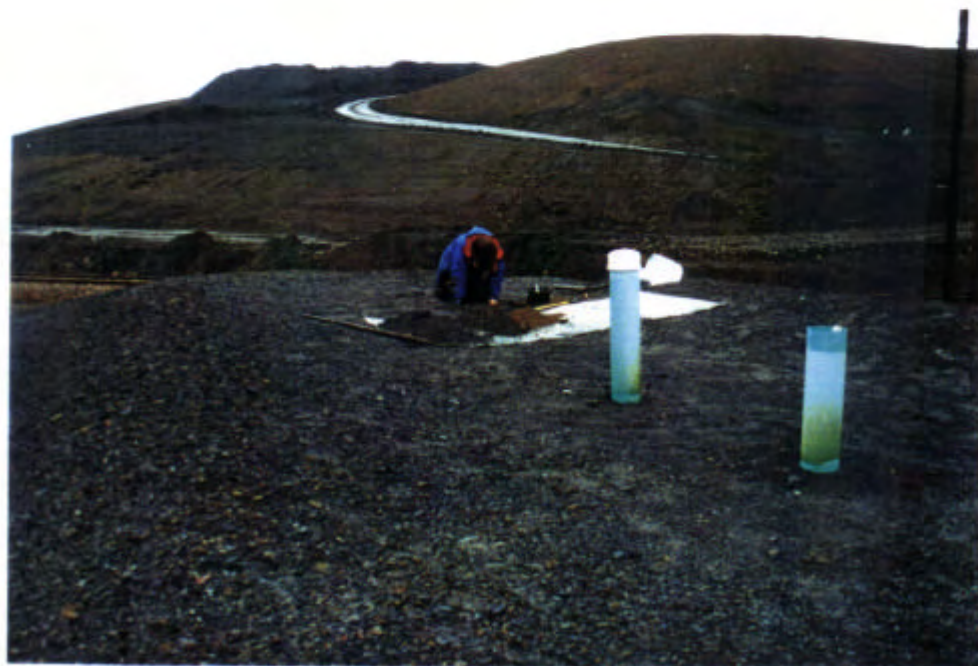
Plate 50: PERD Pile 5, Compacted, Phosphate Amended, November 11-13, 1996. Depressions built into side to collect water.

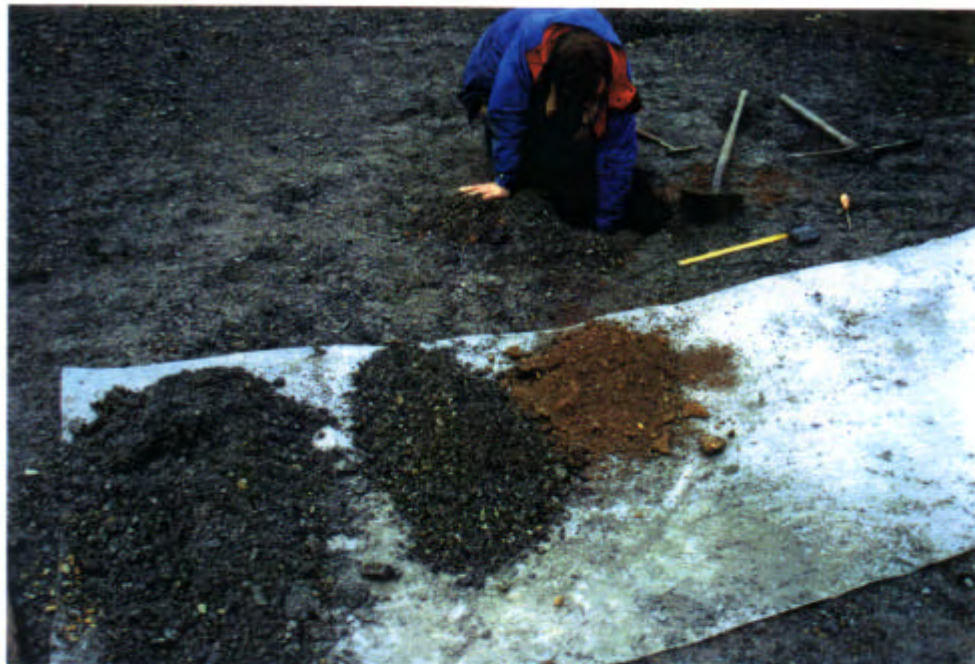
Plate 51: PERD Pile 5, Compacted, Phosphate Amended, November 11-13, 1996. First pit on top.

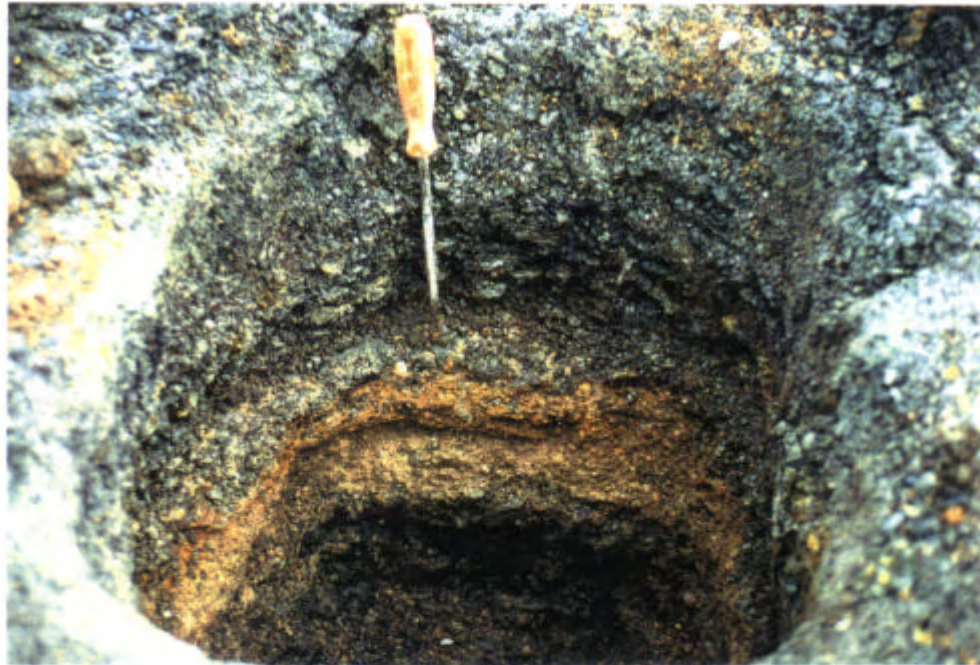
Plate 53: PERD Pile 5, Compacted, Phosphate Amended, November 11-13, 1996.
First pit on top. Phosphate hardpan layer.

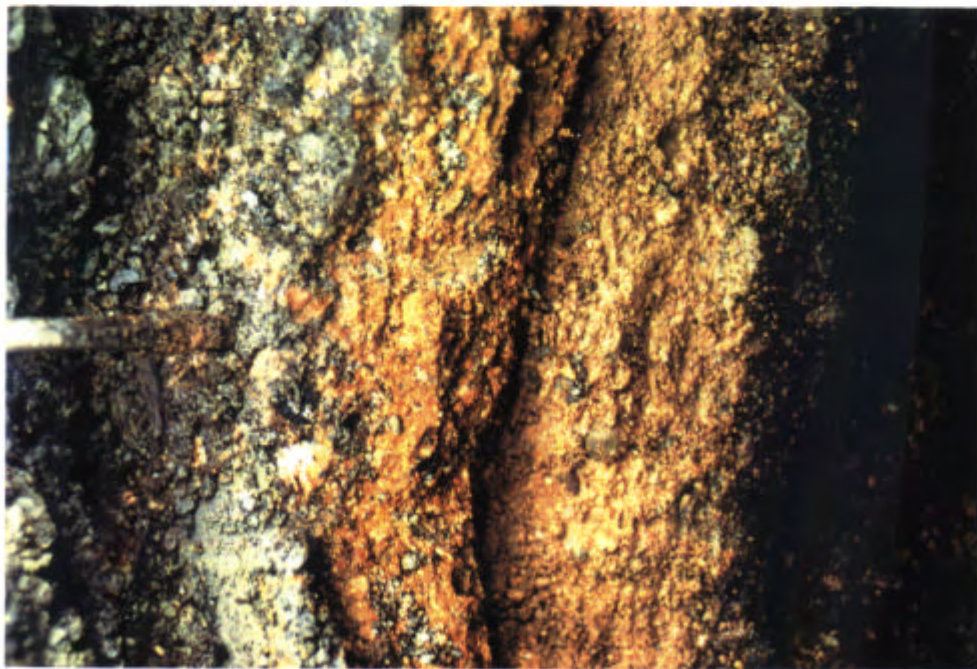
Plate 54: PERD Pile 5, Compacted, Phosphate Amended, November 11-13, 1996. First pit on top. Phosphate hardpan layer.

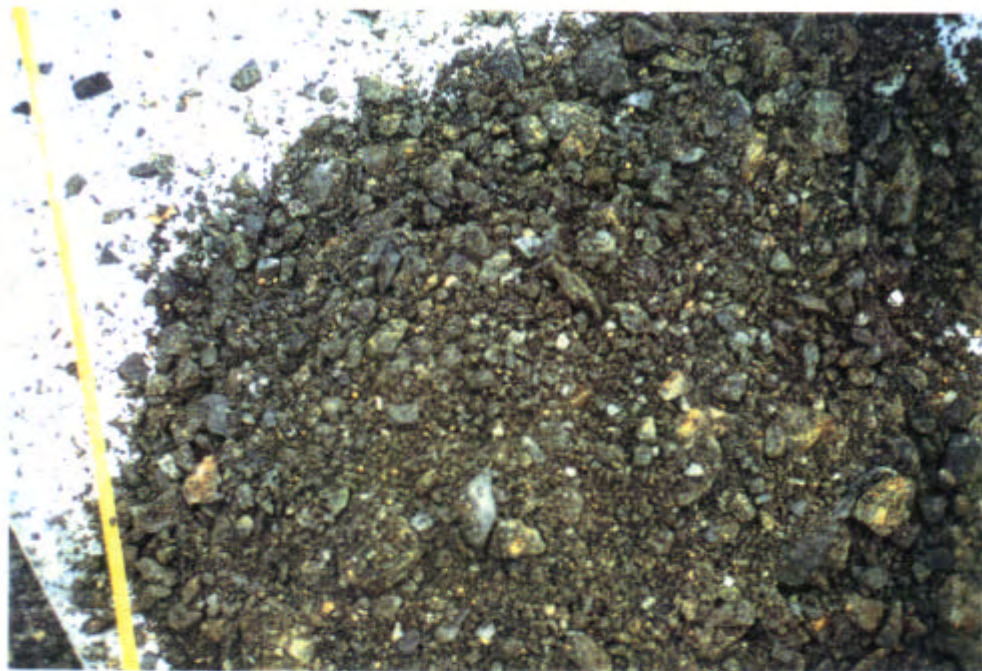
Plate 57: PERD Pile 5, Compacted, Phosphate Amended, November 11-13, 1996. Weathered coarse coal waste from top layer.

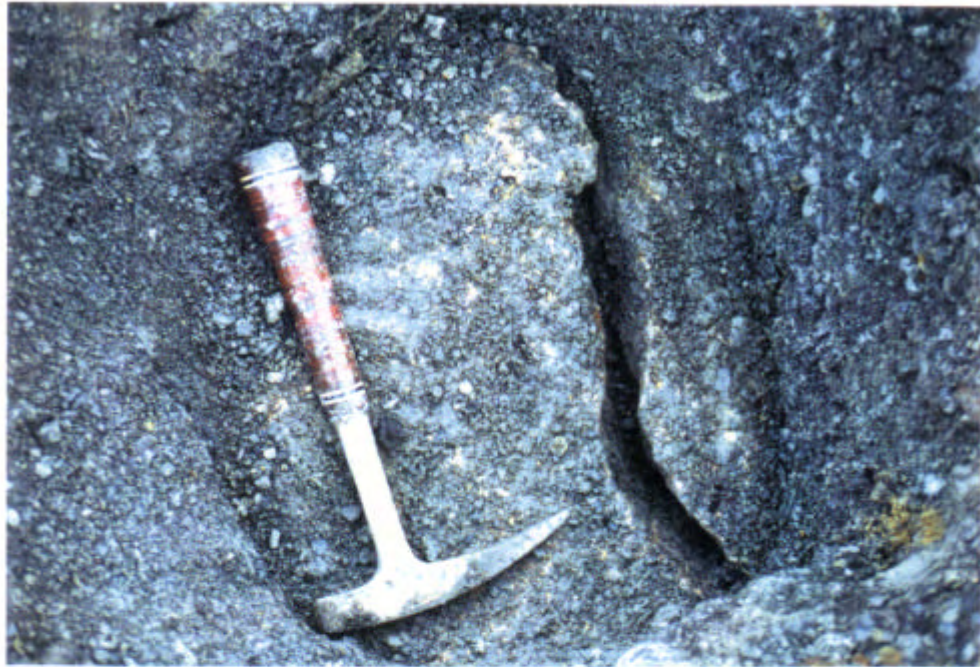
Two similar sized pits were excavated on the top of the pile but near the edge or "shoulder". The pit positioned on the western shoulder indicated similar conditions to that described above, with the exception of two separate but continuous (for at least 0.2-0.3 m) cracks paralleling the edge of the pile. The cracks were 2-5 cm in width and extended to the base of the phosphate layer, which had been entirely turned to hardpan.

Plate 59: PERD Pile 5, Compacted, Phosphate Amended, November 11-13, 1996. Second pit on top shoulder of W facing slope.

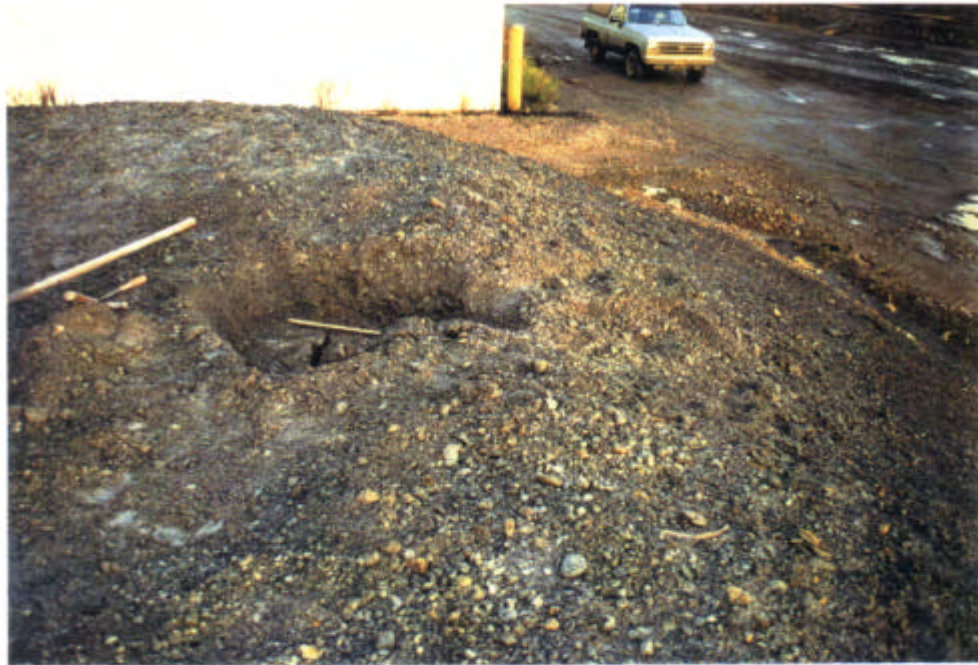
This suggests that after hardening tension cracks formed from the weight of the down slope portion of the hardpan. Although the depth of phosphate allowed the crack to self-heal, the layer eventually ran out and the crack dissected the entire hardpan allowing water and air to permeate into the core of the pile. However, the pit excavated into the shoulder at the southeast corner where the major rill was present, revealed no cracks in the hardpan.

Plate 61: PERD Pile 5, Compacted, Phosphate Amended, November 11-13, 1996.
Exposed hardpan layer with cracks in extended second pit on top shoulder.

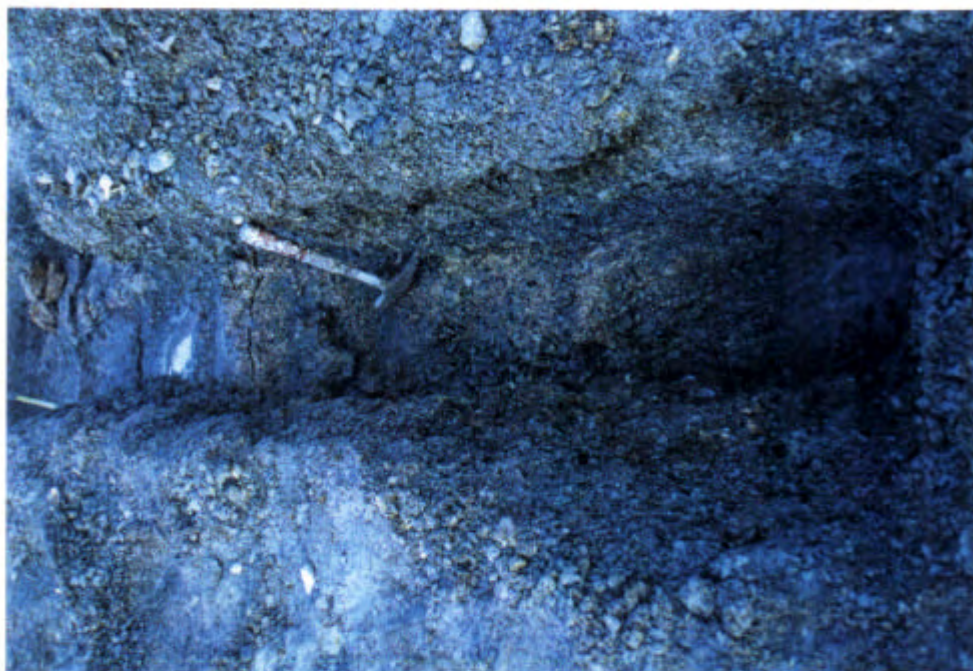
Three trenches were excavated down the side slopes, two on the side slopes and one at the southeast corner which followed the gully downslope. All trenches indicated that the phosphate layer was not constructed over the lower third of the slope. It is thought that this was due to construction problems in placing the material over the steeper lower slopes, required to squeeze Pile 5 into the only space left available. Since the hardpan would not have been properly seated at the toe of the slope, the weight of the hardpan over the slope could have created the tension cracks noted.

Plate 65: PERD Pile 5, Compacted, Phosphate Amended, November 11-13, 1996. West side trench exposing hardpan extending from top surface down side.

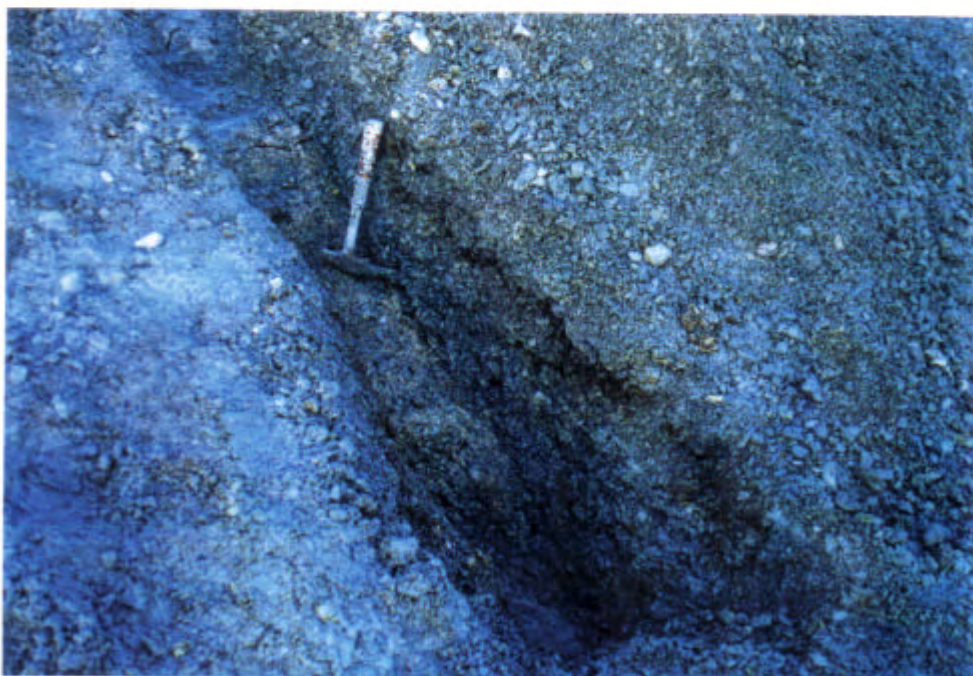
Plate 66: PERD Pile 5, Compacted, Phosphate Amended, November 11-13, 1996. West side trench exposing hardpan extending from top surface down side.

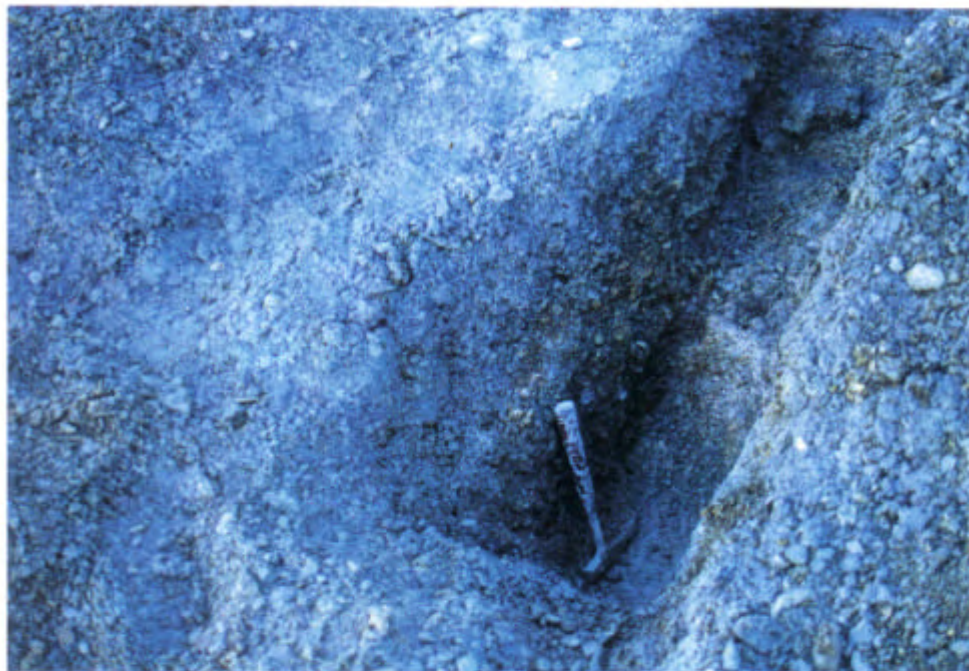
Plate 67: PERD Pile 5, Compacted, Phosphate Amended, November 11-13, 1996. West side trench exposing hardpan extending from top surface down side.

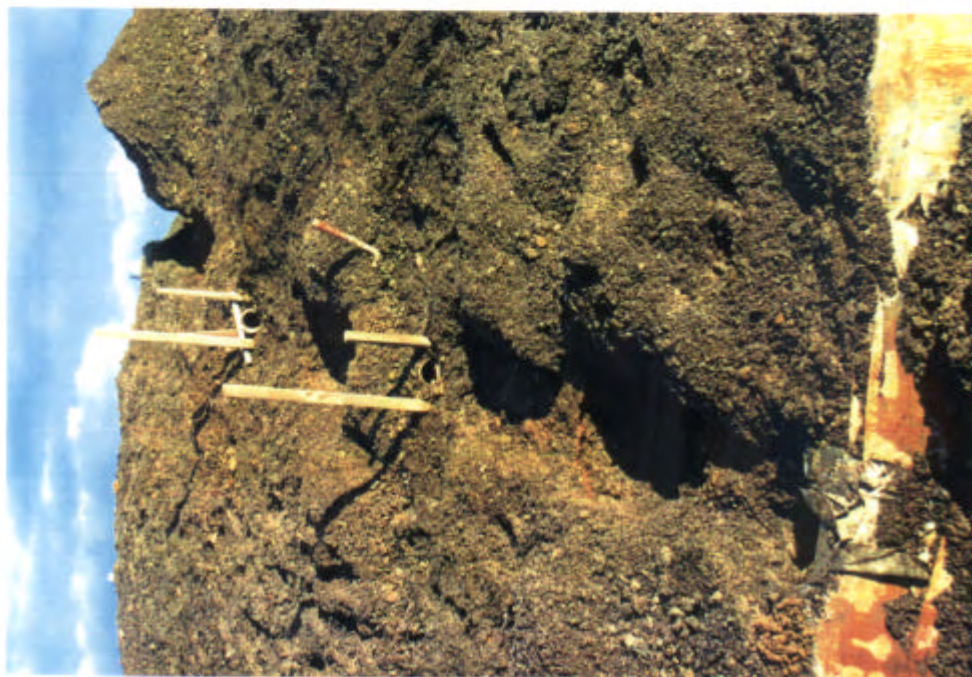
Plate 68: PERD Pile 5, Compacted, Phosphate Amended, November 11-13, 1996.
West side trench extending from top surface down side.

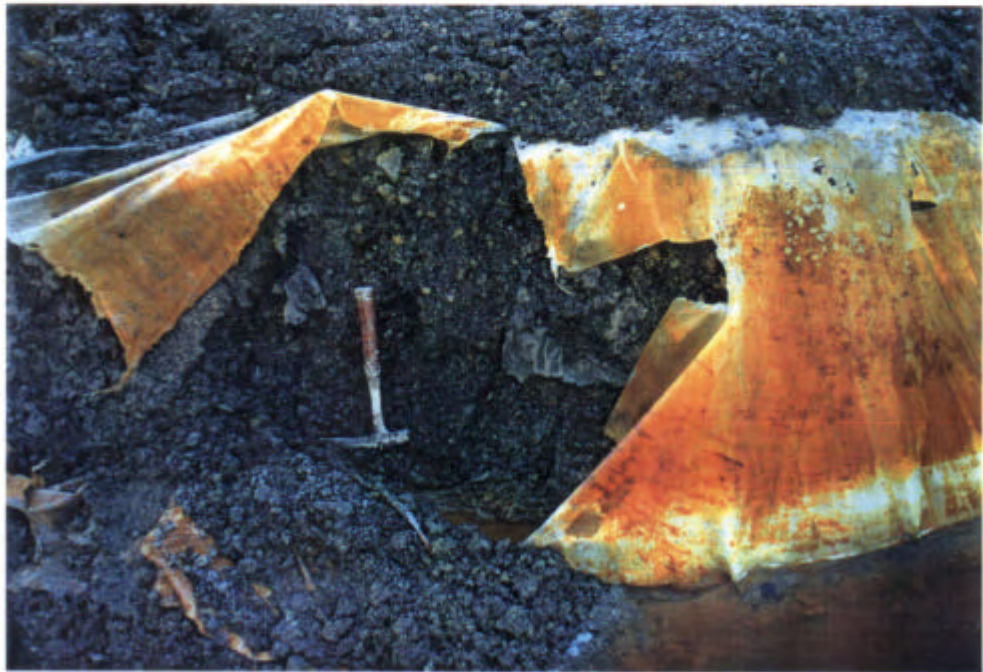
Plate 70: PERD Pile 5, Compacted, Phosphate Amended, November 11-13, 1996.
Base of west side trench showing end of phosphate hardpan layer.

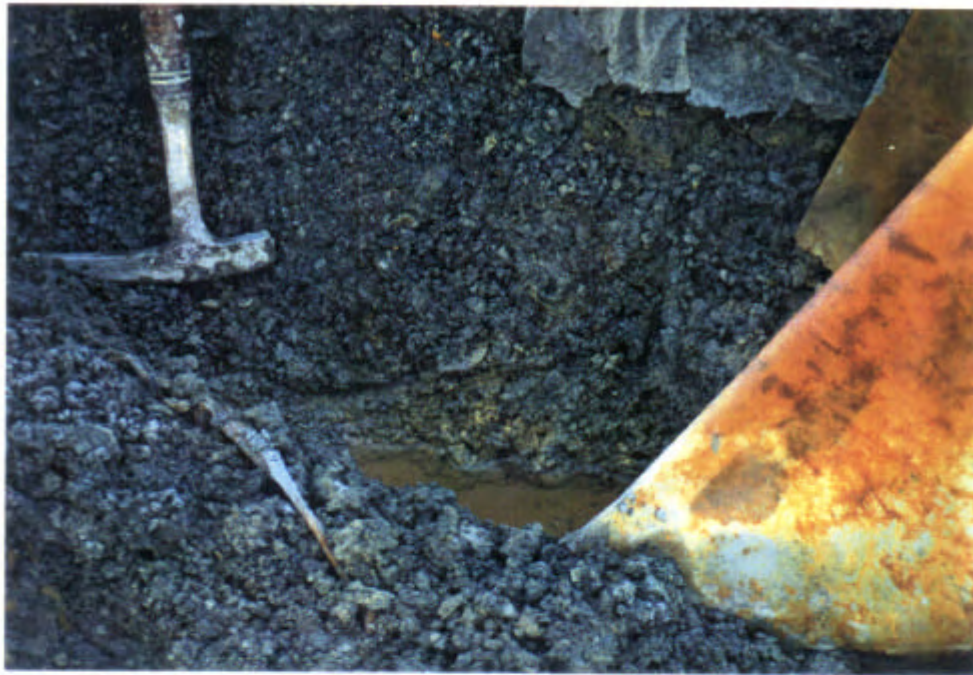
Plate 71: PERD Pile 5, Compacted, Phosphate Amended, November 11-13, 1996.
Base of west side of showing weathered coal waste beneath liner.

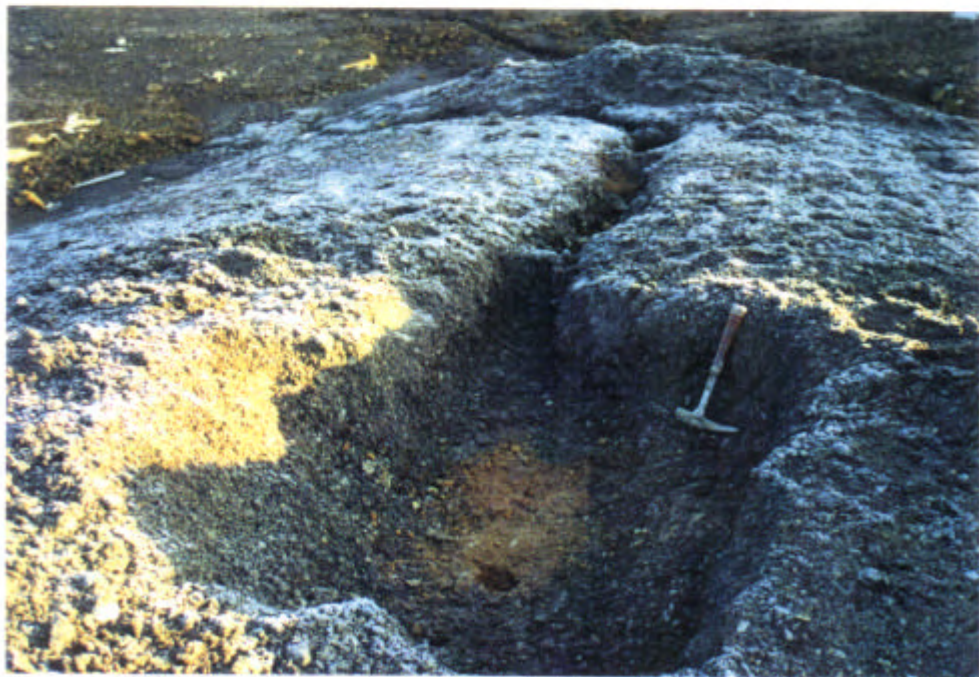
Plate 72: PERD Pile 5, Compacted, Phosphate Amended, November 11-13, 1996. Close-up of base of west side of showing weathered coal waste beneath liner.

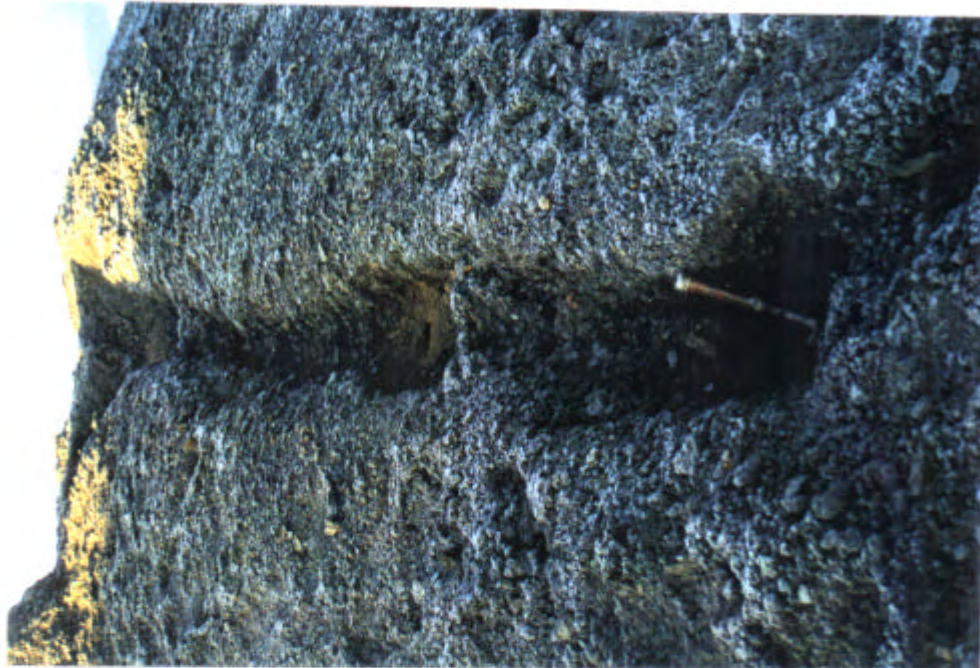
Plate 73: PERD Pile 5, Compacted, Phosphate Amended, November 11-13, 1996. Third pit excavated under natural rill on east side on pile.

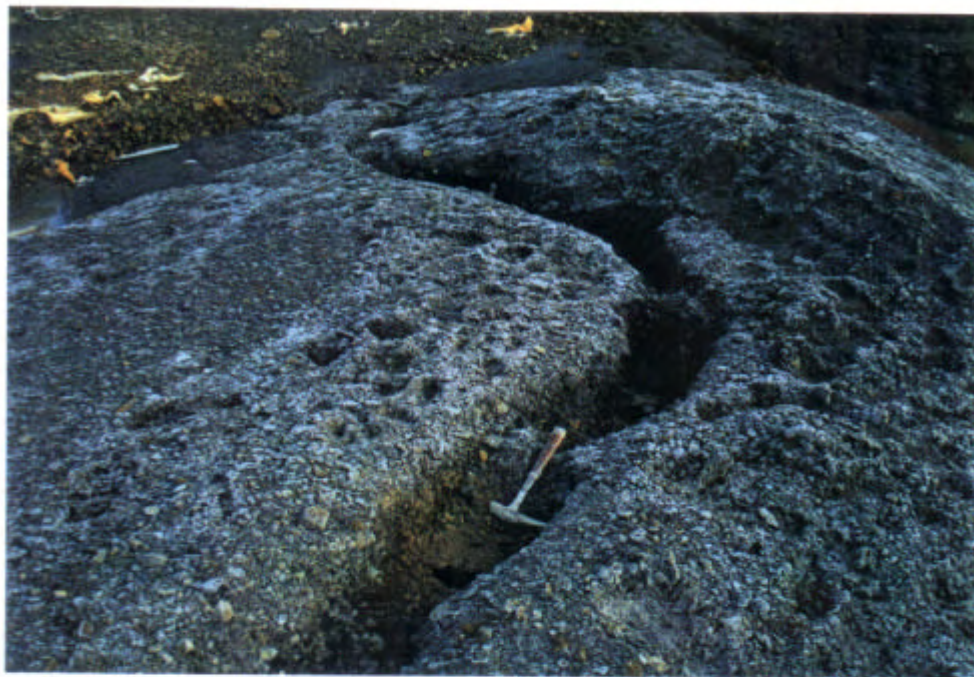
Plate 75: PERD Pile 5, Compacted, Phosphate Amended, November 11-13, 1996. Third pit excavated under natural rill on east side on pile. Note absence of cracks.

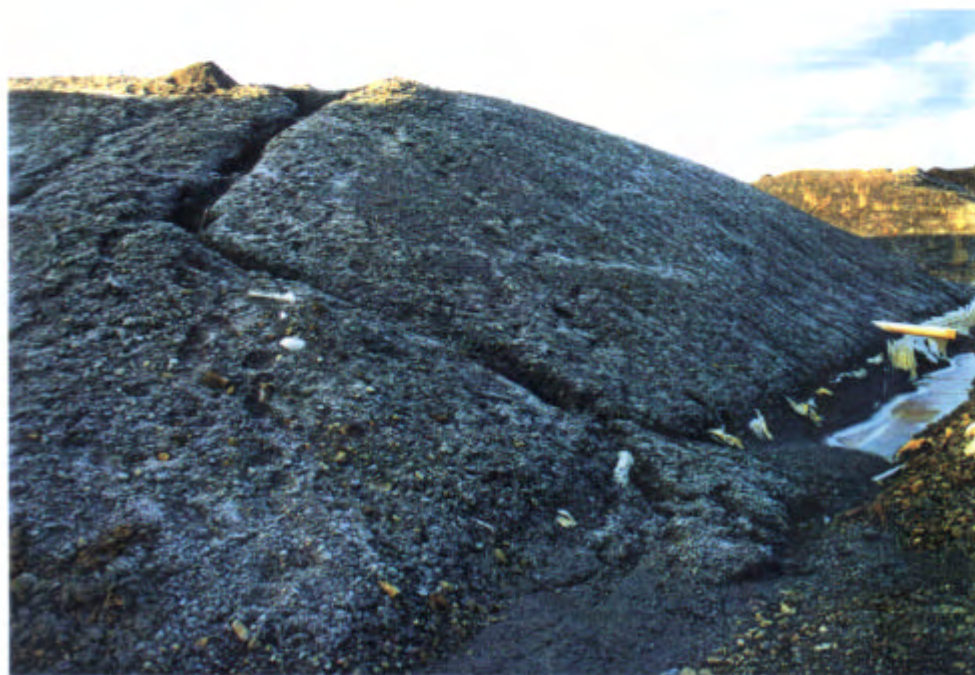
Plate 76: PERD Pile 5, Compacted, Phosphate Amended, November 11-13, 1996.
Third trench excavated under natural rill on east side on pile.

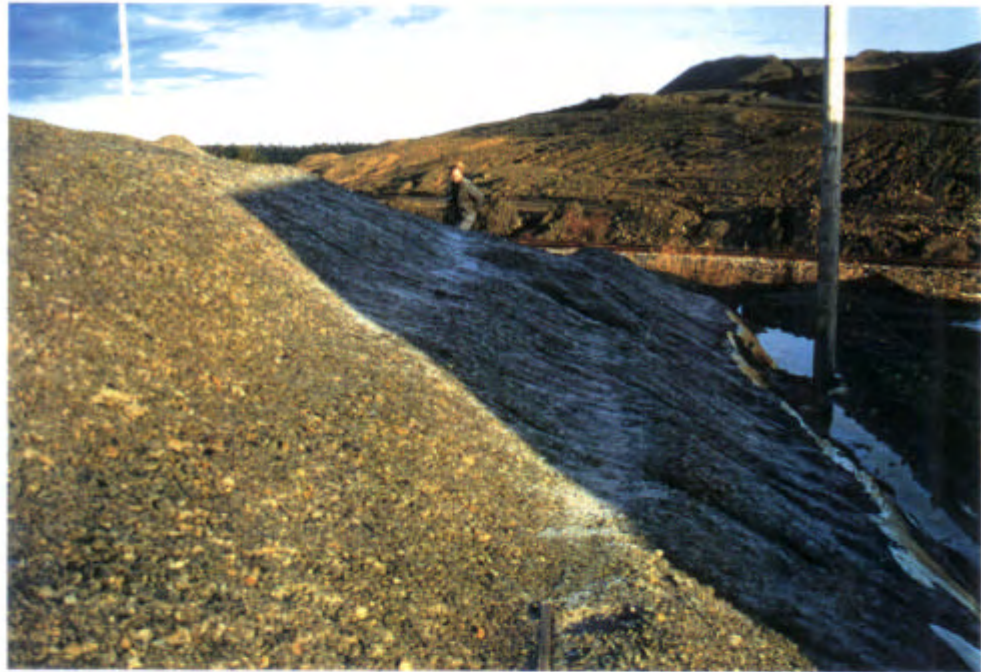
Plate 77: PERD Pile 5, Compacted, Phosphate Amended, November 11-13, 1996.
overview of third trench excavated under natural rill on east side on pile.

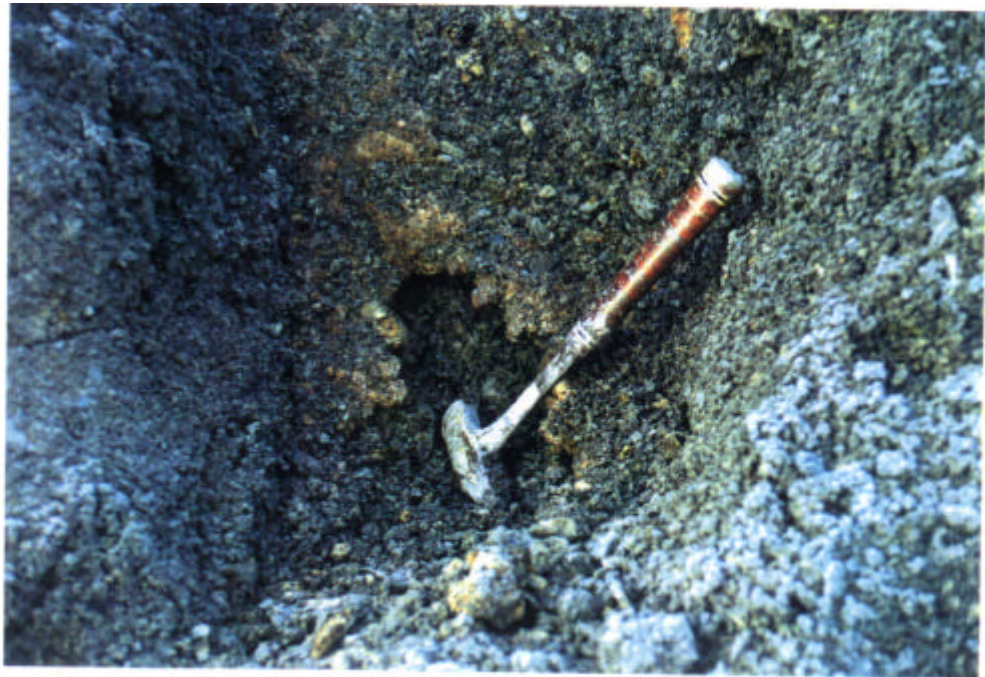
Plate 79: PERD Pile 5, Compacted, Phosphate Amended, November 11-13, 1996.
Excavation on south side of pile exposing limit of phosphate hardpan.
